10-Year Capital Asset Need: Taking Care of What We Have

Ten-year Capital Asset Need: Taking Care of What We Have

DNR capital assets include anything built on DNR land that has a minimum 20-year lifecycle. The DNR first developed a comprehensive Capital Asset Plan in 2015. This is the January 2018 update.

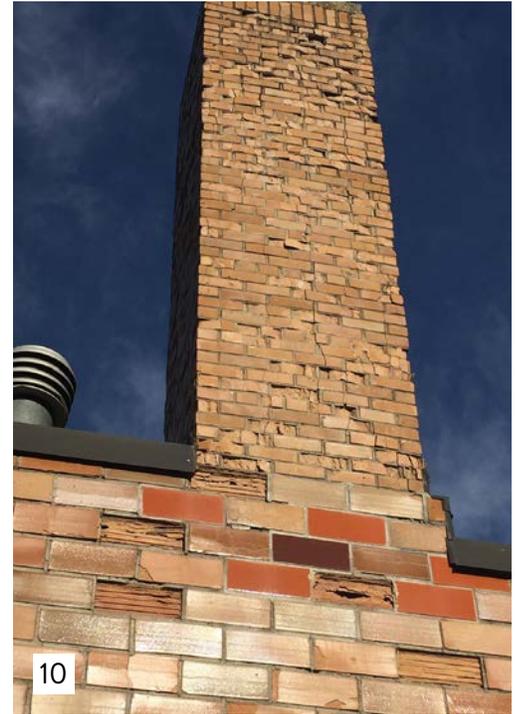
Photo Number 11: Over 673 DNR buildings have a rating of “Poor” or “Unacceptable” with a deferred maintenance backlog of almost \$45.6 million. Twenty-nine of these are report-to-work buildings that house 117 staff.

10. Waterville Fish Hatchery Office
11. Jay Cooke State Park—Oldenberg Sanitation building roof
12. Itasca State Park—Nicollet Court
13. William O'Brien State Park—Contact Station

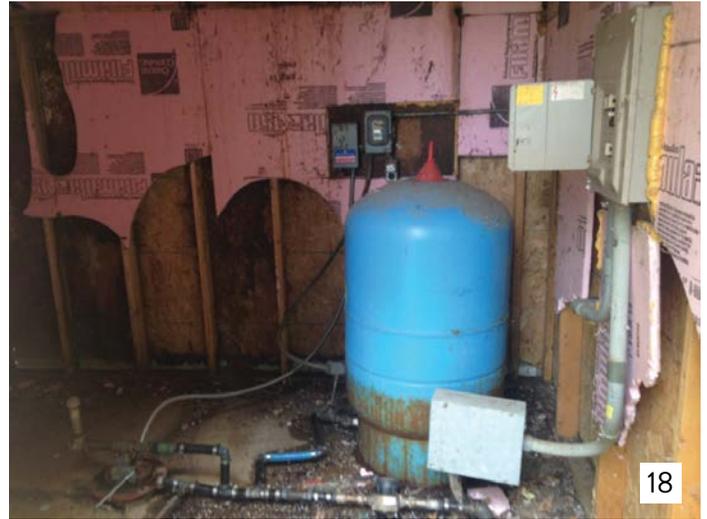
18

18. Blue Mounds State Park—well and pressure system
19. Itasca State Park— failing sewer line
20. Itasca State Park—corroded, galvanized steel water pipes

Aging galvanized steel piping, concrete, and pumps at many DNR facilities are well past their lifecycles. In 2017 we conducted dozens of emergency repairs costing over \$350,000 due to failing water and sewer systems.

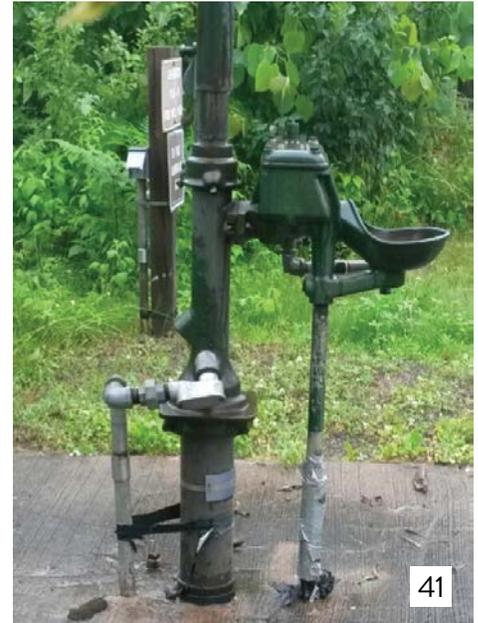
41

41. St. Croix Valley State Forest Horse Camp—water pump
42. Whitewater State Park Cedar Campground— flood damage
43. Frontenac State Park sink hole in campground
